Insights for Insulation Installation

Gordon Hart, Consultant/National Insulation Association

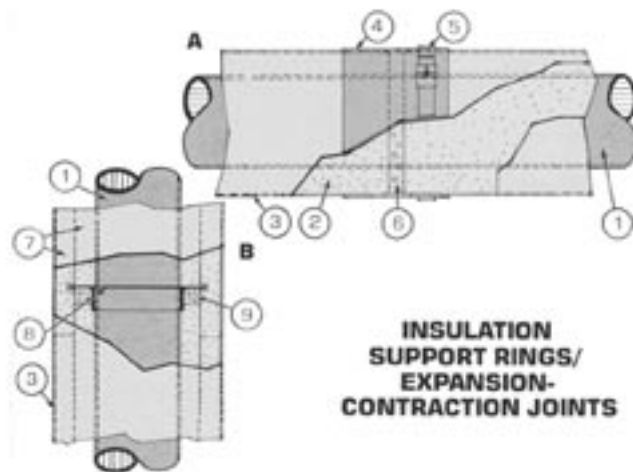
Figure 1. Plate #9 From Midwest Insulation Contractor's Association.

Figure 1 is Plate #9 from the Midwest Insulation Contractor's Association (MICA) *National Commercial & Industrial Insulation Standards* manual (1) showing the correct way to install an expansion/contraction joint at pipe support rings by using a compressible form of insulation in that joint. Figure A, Segment 2 refers to the single-layer pipe insulation. Segment 6 refers to the flexible fibrous insulation in the expansion/contraction joint. Likewise, for the use of a support ring shown in Figure B, Segment 8 is the steel support ring, and Segment 9 is the flexible fibrous insulation used as filler in that otherwise void space.

Gaps can sometimes be the consequence of an inadequate specification—one that does not require expansion/contraction joints (through the installation of a compressible insulation material in the butt joints between adjacent pieces of rigid insulation), or does not require double layer on thick insulation applications. However, gaps can also occur when insulators simply neglect to install the compressible insulation in those expansion joints, and inspectors do not catch the deficiency.

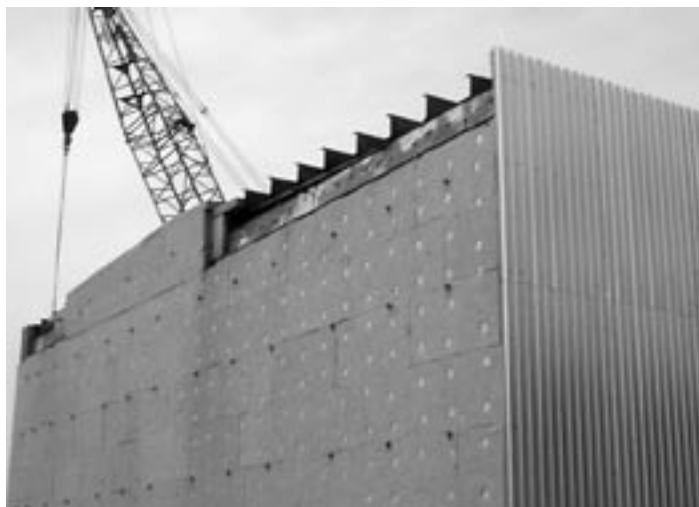
Photo 1. Insulation panels during installation.

Photo 1 shows insulation panels during installation. A good QA program would require a quality control (QC) inspector to perform inspections using a sampling plan that represents some percentage of the insulation boards' installation, prior to covering it with the metal jacketing. Once covered, it is very difficult to evaluate the installation quality of the insulation boards other than with IR spectrometry.

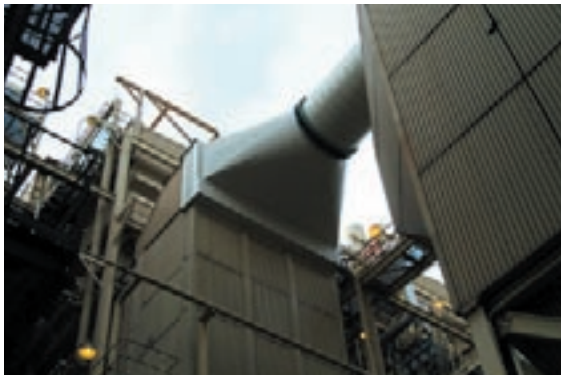
Photo 2a. Visual of panel system.

Photo 2a shows a section of a panel insulation system, which appears to be in excellent condition. However, Photo 2b the corresponding IR photo, shows areas of high heat loss, caused either by wet insulation or insulation gaps. In this case, the IR inspection reveals a serious insulation deficiency beneath the connection between the horizontal duct and the vertical panels. The surface temperatures in this area are as high as 149°F, whereas the general surface temperatures on the flat panels are only in the range of 50°F and 70°F.

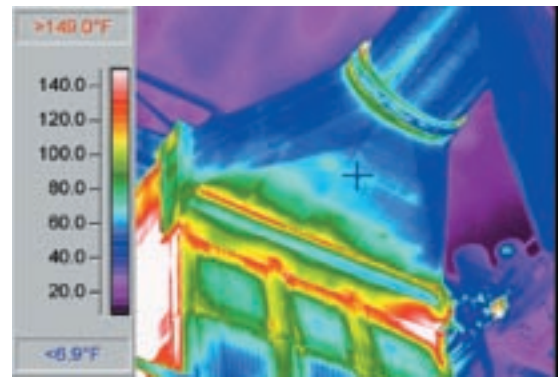
Photo 2b. Infrared photo of the same panel system showing high surface below the connecting horizontal duct.

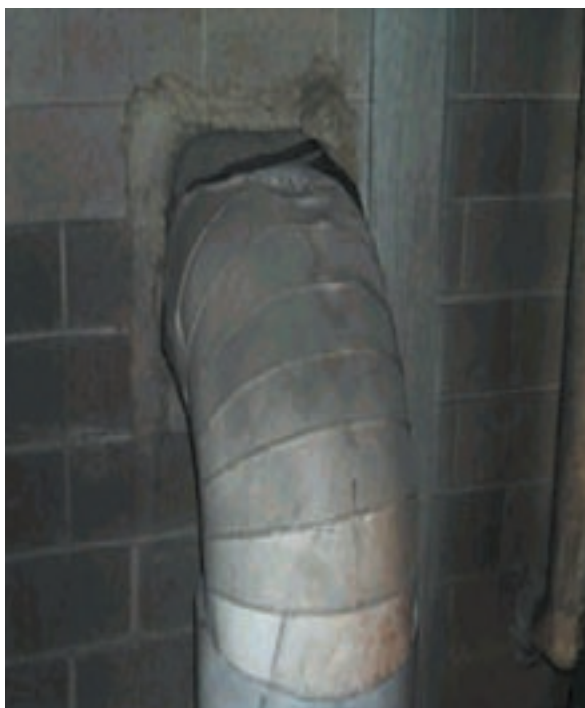
Another example of the power of IR inspections is shown in Photos 3a and 3b. The former is a photo of an elbow. While the photo shows that there is some obvious physical damage to the metal jacketing, the extent of the damage is not revealed until you look at the corresponding IR image. Note that the surface temperatures on the top of the elbow reach as high as 211.5°F. While the IR photo does not show the portions of the pipe below the elbow, the scale does indicate that there are insulation surfaces with temperatures as low as 92.9°F. The high surface temperatures indicate areas with excessive heat loss, probably caused by wet and/or damaged thermal insulation beneath the jacketing.

Photo 3a. Partially damaged insulation on a pipe elbow.

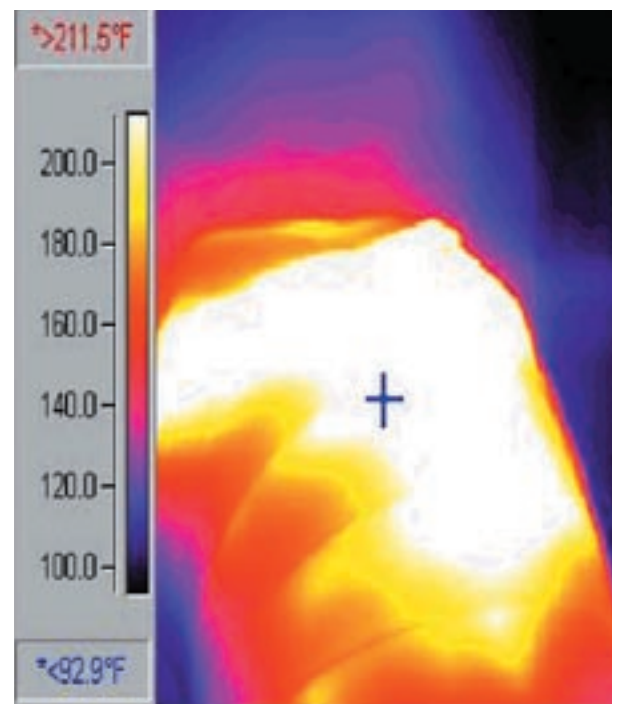
Photo 3b. An infrared photograph of the top of the same areas as seen in Photo 3a showing an area with high surface temperatures.

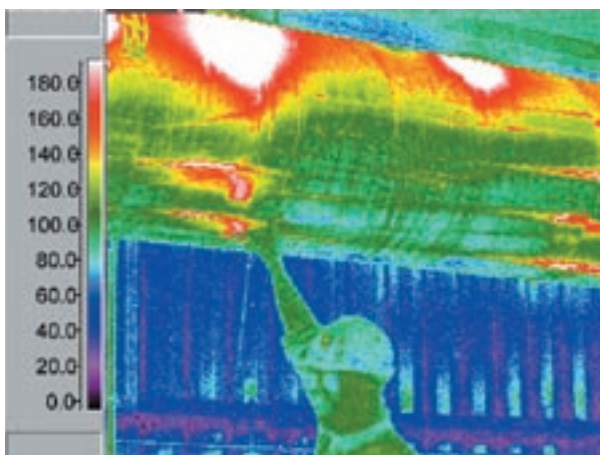
Photo 4. An insulated horizontal seam shows two large areas on the top surface with surface temperatures in excess of 180°F, as well as some smaller areas on the lower half of the pipe. Note that the well-insulated areas have surface temperatures in the 80°F to 100°F range.

Photo 4 shows the successful use of IR thermography to detect areas of high heat loss, in this case on a horizontal, insulated pipe. While it is not obvious what is causing the two areas of high surface temperature on the subject pipe, it is clear that there is something defective about the insulation material, either being wet, damaged, or incompletely installed.
